**Flood Control Project Maintenance
Levee Inspections**
LMA District Cover Sheet
Spring 2017 Levee Inspection Results

Reclamation District No. 0544 Upper Roberts Island

Spring 2017 Levee Inspection Results

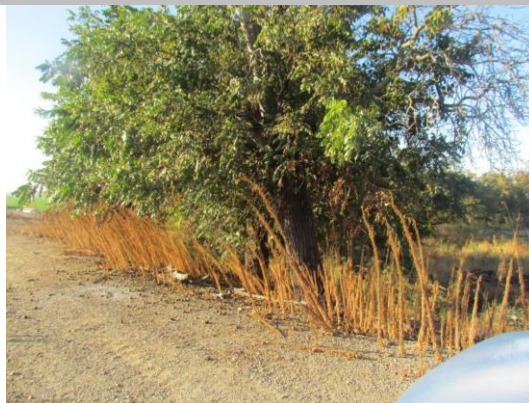
Photo 1 of 1 : SP_2017_RD0544_108_92_20170316_00058.jpg

LM Start	0.01	Rating **	U	Issue No.	92
LM End	0.01	Issue Type +	Ma	Location *	LS
Category	Earthen Levee			GPS Latitude/Longitude	
				Start	End
Item	Trim / Thin Trees			37.870285 °	37.870285 °
				-121.329822 °	-121.329822 °
DWR ID	DWR_RD0544_01_f_2014_92				
Comment Code					
T1 : Trim trees to at least five feet above ground level.					
Inspector Comment					
Untrimmed tree on landward slope.

Looking southwest at untrimmed tree on landward slope.

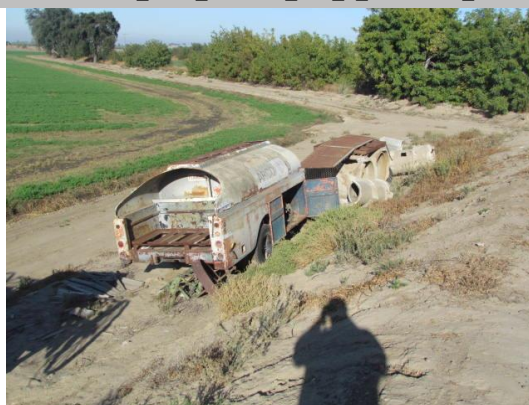
Photo 1 of 5 : SP_2017_RD0544_108_4_20170316_00004.jpg

LM Start	0.06	Rating **	M	Issue No.	4
LM End	0.19	Issue Type +	En	Location *	LS
Category	Earthen Levee			GPS Latitude/Longitude	
				Start	End
Item	Encroachments			37.869606 °	37.868163 °
				-121.329571 °	-121.328132 °
DWR ID	DWR_RD0544_01_s_2012_4				
Comment Code					
EQ : Equipment					
Inspector Comment					
Farm equipment and supplies stored at landward toe.

Looking west at equipment stored at landward toe fall 2015

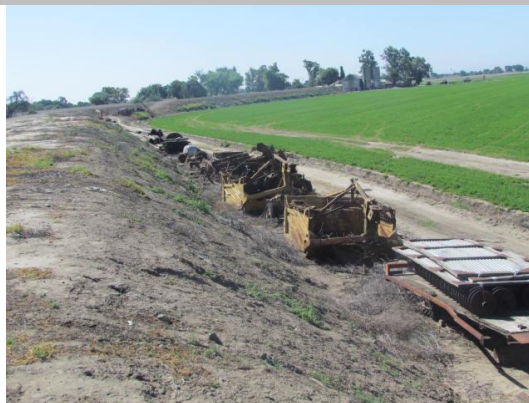
Photo 3 of 5 : SP_2017_RD0544_108_4_20170316_00006.jpg

Looking south at farm equipment at landward toe. (Spring 2015)

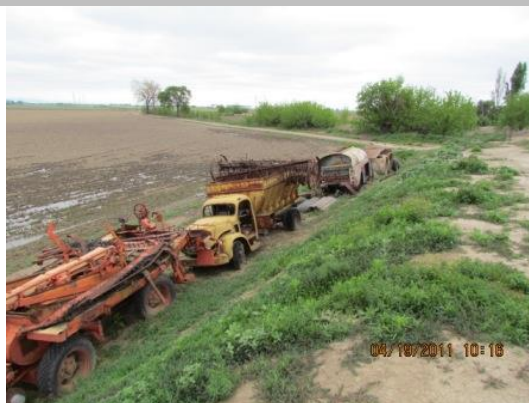
Photo 4 of 5 : SP_2017_RD0544_108_4_20170316_00007.jpg

Looking north at equipment along landside toe.

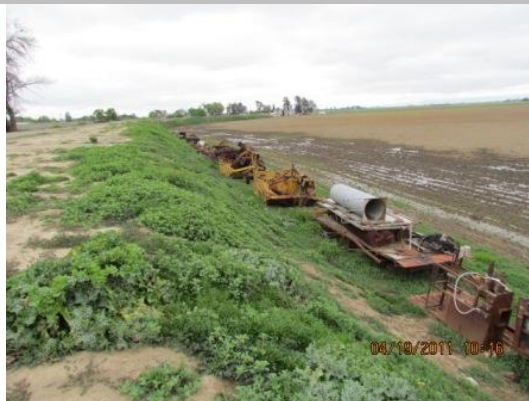
Photo 5 of 5 : SP_2017_RD0544_108_4_20170316_00008.jpg

Looking south at equipment along landside toe.

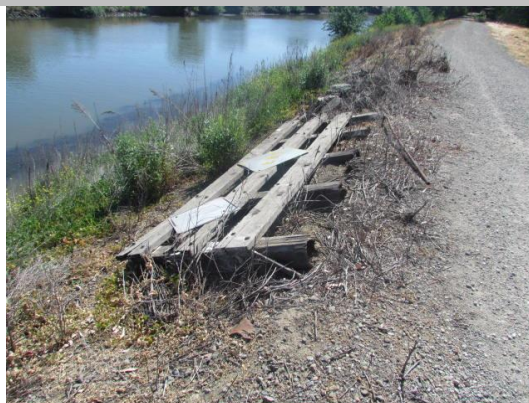
Photo 1 of 1 : SP_2017_RD0544_108_86_20170316_00055.jpg

LM Start	0.64	Rating **	U	Issue No.	86
LM End	0.64	Issue Type +	Ma	Location *	WS
Category	Earthen Levee			GPS Latitude/Longitude	
				Start	End
Item	Encroachments			37.863972 °	37.863972 °
				-121.323443 °	-121.323443 °
DWR ID	DWR_RD0544_01_s_2015_86				
Comment Code					
GA : Garbage					
Inspector Comment					
Old "dead end" sign on waterward slope.

Looking southeast at wooden sign on waterward slope.

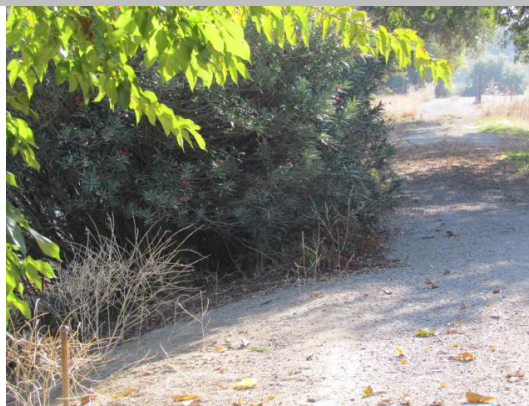
Photo 1 of 1 : SP_2017_RD0544_108_10_20170316_00012.jpg

LM Start	0.70	Rating **	U	Issue No.	10
LM End	0.70	Issue Type +	En	Location *	WS
Category	Earthen Levee			GPS Latitude/Longitude	
				Start	End
Item	Vegetation			37.863575 °	37.863575 °
				-121.322367 °	-121.322367 °
DWR ID	DWR_RD0544_01_s_2012_10				
Comment Code					
V6 : Landscaping					
Inspector Comment					
Oleander on waterward slope.

Looking south at dense oleanders on waterward slope fall 2015.

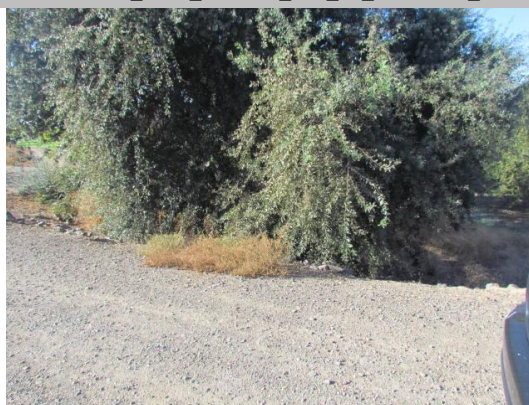
Photo 1 of 1 : SP_2017_RD0544_108_93_20170316_00059.jpg

LM Start	0.81	Rating **	U	Issue No.	93
LM End	0.81	Issue Type +	Ma	Location *	LS
Category	Earthen Levee			GPS Latitude/Longitude	
				Start	End
Item	Trim / Thin Trees			37.862694 °	37.862694 °
				-121.320887 °	-121.320887 °
DWR ID	DWR_RD0544_01_f_2014_93				
Comment Code					
T1 : Trim trees to at least five feet above ground level.					
Inspector Comment

Looking west at untrimmed trees on landward slope and toe fall 2015.

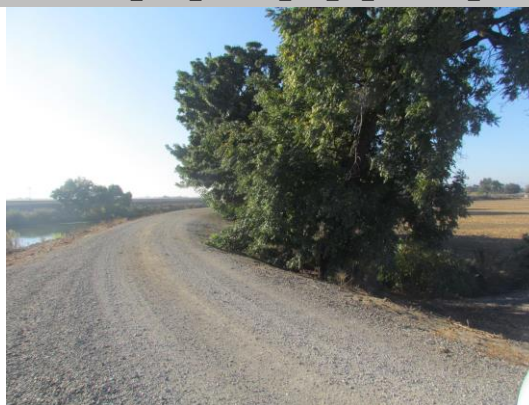
Photo 1 of 1 : SP_2017_RD0544_108_39_20170316_00030.jpg

LM Start	1.12	Rating **	U	Issue No.	39
LM End	1.12	Issue Type +	Ma	Location *	LS
Category	Earthen Levee			GPS Latitude/Longitude	
				Start	End
Item	Trim / Thin Trees			37.859423 °	37.859423 °
				-121.318328 °	-121.318328 °
DWR ID	DWR_RD0544_01_s_2012_39				
Comment Code					
T1 : Trim trees to at least five feet above ground level.					
Inspector Comment					
Untrimmed trees on landward slope.

Looking southwest at untrimmed tree on landward slope.

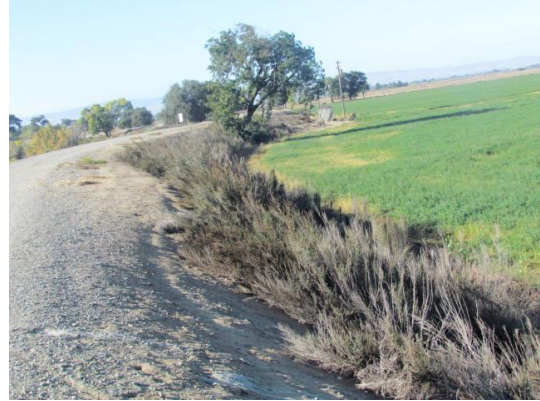
Photo 1 of 1 : SP_2017_RD0544_108_15_20170316_00014.jpg

LM Start	1.13	Rating **	M	Issue No.	15
LM End	1.30	Issue Type +	Ma	Location *	LS
Category	Earthen Levee			GPS Latitude/Longitude	
				Start	End
Item	Vegetation			37.859287 °	37.857322 °
				-121.318333 °	-121.319985 °
DWR ID	DWR_RD0544_01_s_2012_15				
Comment Code					
V2 : Remove the wild growth other than native grasses from the levee slopes.					
Inspector Comment

Looking southeast at dense vegetation on landward toe.

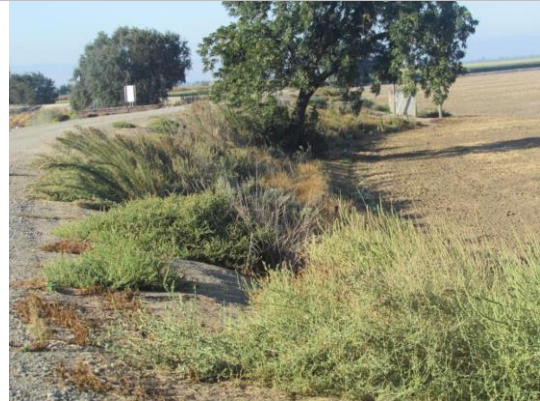
Photo 1 of 1 : SP_2017_RD0544_108_89_20170316_00057.jpg

LM Start	1.29	Rating **	U	Issue No.	89
LM End	1.29	Issue Type +	Ma	Location *	LS
Category	Earthen Levee			GPS Latitude/Longitude	
				Start	End
Item	Trim / Thin Trees			37.857321 °	37.857321 °
				-121.319943 °	-121.319943 °
DWR ID	DWR_RD0544_01_s_2014_89				
Comment Code					
T1 : Trim trees to at least five feet above ground level.					
Inspector Comment					
Dense vegetation on landward slope.

Looking southwest at dense veg on landward slope and toe.

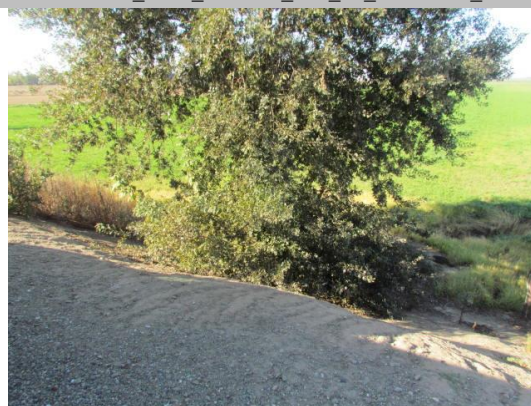
Photo 1 of 1 : SP_2017_RD0544_108_87_20170316_00056.jpg

LM Start	1.42	Rating **	U	Issue No.	87
LM End	1.48	Issue Type +	Ma	Location *	LS
Category	Earthen Levee			GPS Latitude/Longitude	
				Start	End
Item	Trim / Thin Trees			37.855948 °	37.855043 °
				-121.321250 °	-121.321122 °
DWR ID	DWR_RD0544_01_s_2015_87				
Comment Code					
T1 : Trim trees to at least five feet above ground level.					
Inspector Comment

Looking west at untrimmed tree at landward toe fall 2015.

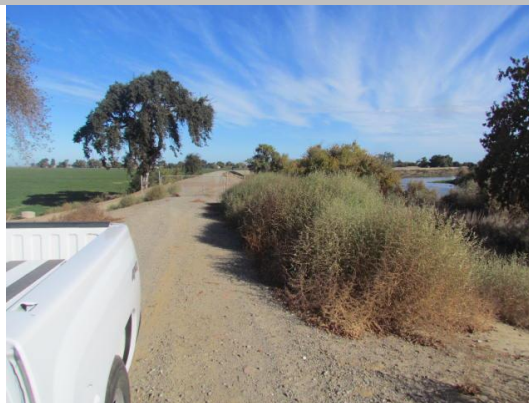
Photo 1 of 1 : SP_2017_RD0544_108_94_20170316_00060.jpg

LM Start	1.48	Rating **	M	Issue No.	94
LM End	1.50	Issue Type +	Ma	Location *	WS
Category	Earthen Levee			GPS Latitude/Longitude	
				Start	End
Item	Vegetation			37.855097 °	37.854722 °
				-121.321136 °	-121.321072 °
DWR ID	DWR_RD0544_01_f_2014_94				
Comment Code					
V2 : Remove the wild growth other than native grasses from the levee slopes.					
Inspector Comment					
Issue has been corrected, but should be monitored.

Looking north at vegetation on waterward shoulder and slope.

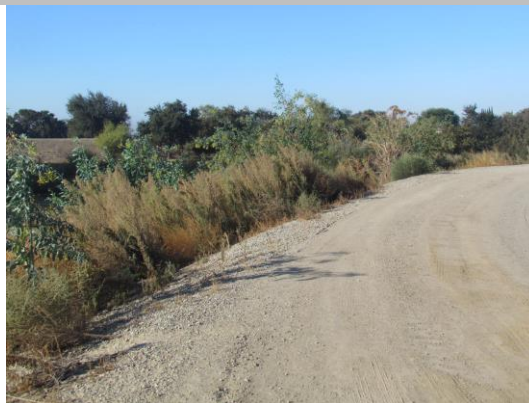
Photo 1 of 1 : SP_2017_RD0544_108_43_20170316_00033.jpg

LM Start	1.57	Rating **	U	Issue No.	43
LM End	1.76	Issue Type +	Ma	Location *	WS
Category	Earthen Levee			GPS Latitude/Longitude	
				Start	End
Item	Vegetation			37.854108 °	37.853980 °
				-121.321582 °	-121.324213 °
DWR ID	DWR_RD0544_01_s_2012_43				
Comment Code					
V2 : Remove the wild growth other than native grasses from the levee slopes.					
Inspector Comment					
Dense vegetation waterward slope.

Looking east at dense veg on waterward slope.

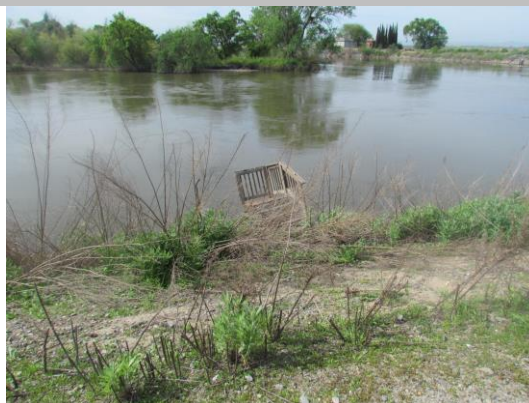
Photo 1 of 1 : SP_2017_RD0544_108_79_20170407_00128.jpg

LM Start	1.63	Rating **	M	Issue No.	79
LM End	1.63	Issue Type +	Ma	Location *	WS
Category	Earthen Levee			GPS Latitude/Longitude	
				Start	End
Item	Encroachments			37.854598 °	37.854598 °
				-121.322320 °	-121.322320 °
DWR ID	DWR_RD0544_01_s_2017_79				
Comment Code					
GA : Garbage					
Inspector Comment					
Remove abandoned stairs to boat dock.

Looking southeast at abandoned wooden boat dock stairs on waterward slope.

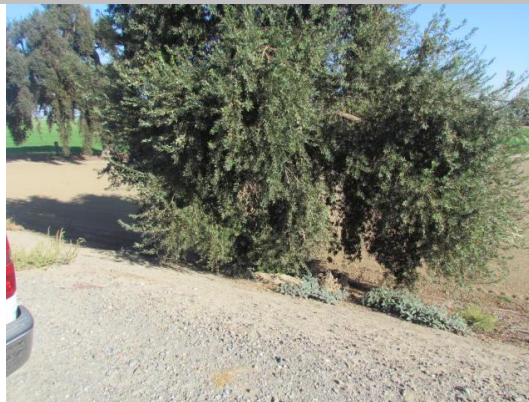
Photo 1 of 1 : SP_2017_RD0544_108_96_20170316_00062.jpg

LM Start	1.64	Rating **	U	Issue No.	96
LM End	1.64	Issue Type +	Ma	Location *	LS
Category	Earthen Levee			GPS Latitude/Longitude	
				Start	End
Item	Trim / Thin Trees			37.854681 °	37.854681 °
				-121.322493 °	-121.322493 °
DWR ID	DWR_RD0544_01_f_2014_96				
Comment Code					
T2 : Thin trees to allow visibility of the ground and room to flood fight.					
Inspector Comment

Looking at untrimmed tree on landward slope and toe.

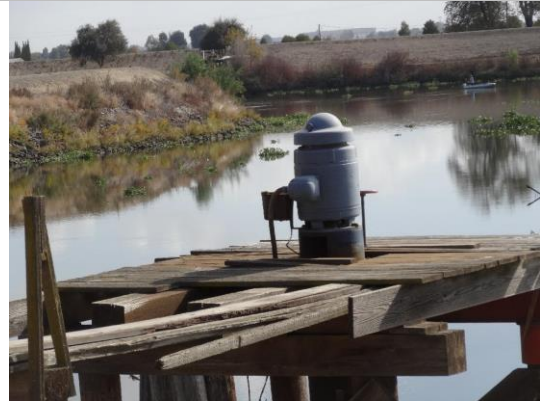
Photo 2 of 3 : UCIP_SP_2017_51351_41785.jpg

Comment Code					
Inspector Comment					
FS_ID:51351 DS_ID:22648 EP_NO: 4114 Repair Type: Non-Urgent Crossing Status: Found UCIP Comments: 12/22/2016: No signs of erosion or depressions found on either levee slope. Slope may have been backfilled but cause of original depression (likely a pipe integrity problem) may not have been addressed. Walkway still in poor structural condition. Downgraded this crossing from Urgent to Non-Urgent. (K. Fazel - UCIP)10/29/2013:- levee depression on both sides of the levee.- 2-inch electric conduit on waterside and service pole on landside.Walkway in poor structural condition. (P. Amatya - DWR) FIELD_STRUCT_DESC: 18-inch steel irrigation pipe through the levee, 2 feet below the crown. Pump mounted on a pile structure pier in the stream. Siphon breaker on the apex of the pipe on the landside (LS) slope. Concrete standpipe at the LS toe. 2-inch electric conduit through the levee and service pole on the LS toe. (Permit No. 4114, 1962 - Feck) [Additional Reference(s): USACE San Joaquin O&M Manual 007, April 1964 (HLM 1.75). DWR Levee Log, 2005]. Note: Levee Log cites a 14-inch, Permit No. 4114 cites a 20-inch, O&M Manual cites a 14-inch, 20 feet below the crown. FS Date: 12/22/2016

WS view: pump on wooden pile structure in the stream.

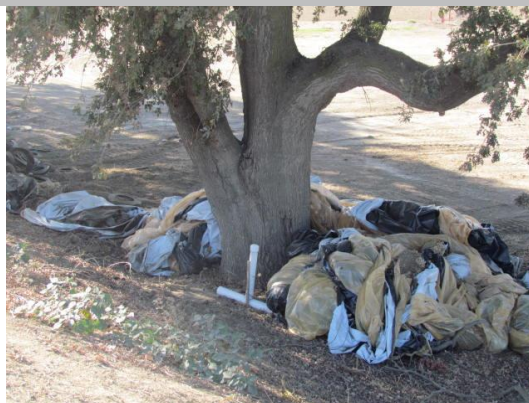
Photo 1 of 2 : SP_2017_RD0544_108_64_20170316_00046.jpg

LM Start	1.91	Rating **	U	Issue No.	64
LM End	1.93	Issue Type +	En	Location *	LS
Category	Earthen Levee			GPS Latitude/Longitude	
				Start	End
Item	Encroachments			37.852006 °	37.851746 °
				-121.323554 °	-121.323328 °
DWR ID	DWR_RD0544_01_f_2015_64				
Comment Code					
GA : Garbage					
Inspector Comment					
Plastic sheeting and rubber tires stored at landward toe.

Looking west at plastic sheeting stored at landward toe.

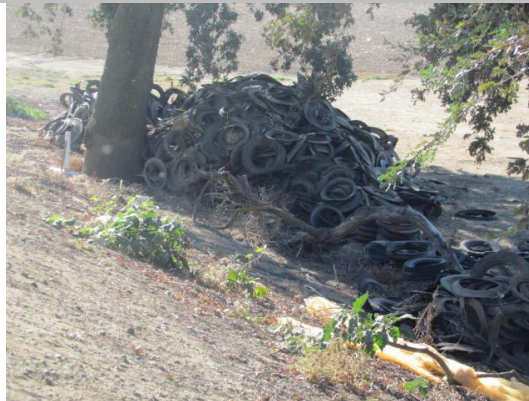
Photo 2 of 2 : SP_2017_RD0544_108_64_20170316_00047.jpg

Looking southwest at rubber tires stored at landward toe.

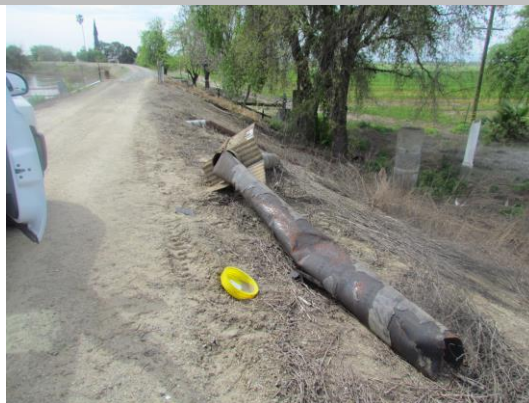
Photo 1 of 1 : SP_2017_RD0544_108_82_20170407_00131.jpg

LM Start	2.25	Rating **	M	Issue No.	82
LM End	2.25	Issue Type +	Ma	Location *	LS
Category	Earthen Levee			GPS Latitude/Longitude	
				Start	End
Item	Encroachments			37.848302 °	37.848302 °
				-121.324877 °	-121.324877 °
DWR ID	DWR_RD0544_01_s_2017_82				
Comment Code					
EQ : Equipment					
Inspector Comment					
Old irrigation pipe.

Looking southwest at old irrigation pipe on landward shoulder.

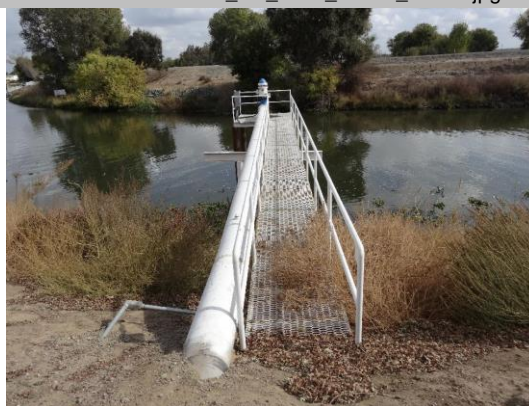
Photo 1 of 3 : UCIP_SP_2017_51352_42007.jpg

Comment Code					
Inspector Comment					
FS_ID:51352					
DS_ID:22650					
EP_NO: N/A					
Repair Type: Urgent					
Crossing Status: Found					
UCIP Comments: 12/22/2016: Erosion of LS slope along pipe alignment. (K. Fazel - UCIP)10/29/2013:Siphon breaker on the landward slope not found. It has been removed and pipe plugged.Huge levee slope erosion on landside.2-inch electric conduit on waterside, service pole on landside. (P. Amatya - DWR)					
FIELD_STRUCT_DESC: 14-inch steel irrigation pipe through the levee, 2 feet below the crown. Pump on pile structure in the stream. Steel walkway to the pump. 2-inch electric conduit on waterside (WS), power pole on landside (LS). [Additional Reference(s): DWR Levee Log, 2005. USACE San Joaquin O&M Manual, April 1964 (HLM 2.26)].					
FS Date: 12/22/2016

WS view: steel pipe, walkway to the pump, conduit (bottom left) on levee slope.

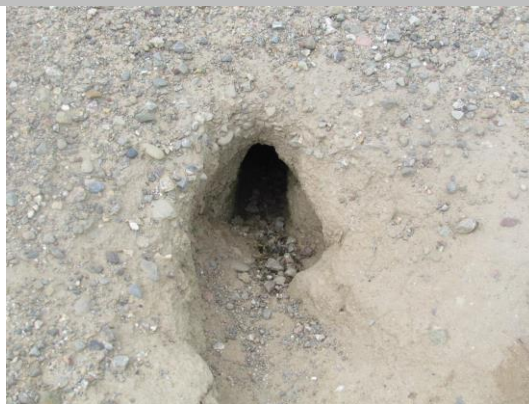
Photo 1 of 3 : SP_2017_RD0544_108_34_20170410_00134.jpg

LM Start	2.32	Rating **	U	Issue No.	34
LM End	2.36	Issue Type +	Ma	Location *	LS
Category	Earthen Levee			GPS Latitude/Longitude	
				Start	End
Item	Animal Control			37.847292 °	37.846743 °
				-121.324662 °	-121.324336 °
DWR ID	DWR_RD0544_01_s_2012_34				
Comment Code					
A1 : Exterminate rodents and backfill and compact or grout burrows.					
Inspector Comment					
Several rodent hole within this reach.

Looking east at large rodent hole on landward slope.

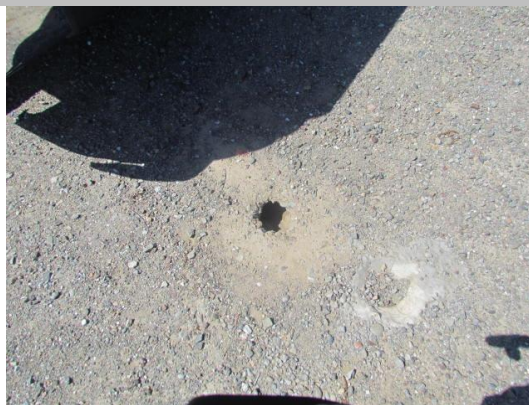
Photo 3 of 3 : SP_2017_RD0544_108_34_20170316_00027.jpg

Looking at rodent hole on levee crown.

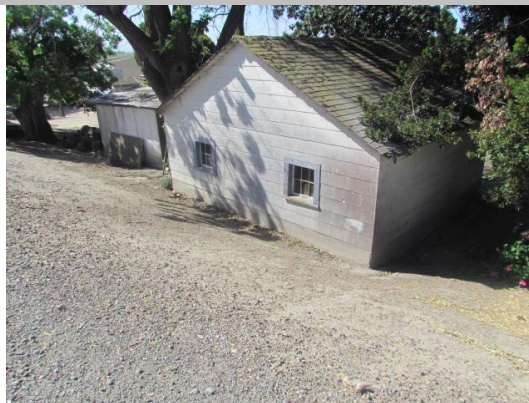
Photo 1 of 1 : SP_2017_RD0544_108_67_20170316_00048.jpg

LM Start	2.38	Rating **	M	Issue No.	67
LM End	2.38	Issue Type +	En	Location *	LS
Category	Earthen Levee			GPS Latitude/Longitude	
				Start	End
Item	Encroachments			37.846508 °	37.846508 °
				-121.324103 °	-121.324103 °
DWR ID	DWR_RD0544_01_s_2013_67				
Comment Code					
BU : Building					
Inspector Comment					
Building has been in place for several years.

Looking southeast at building at landward toe.

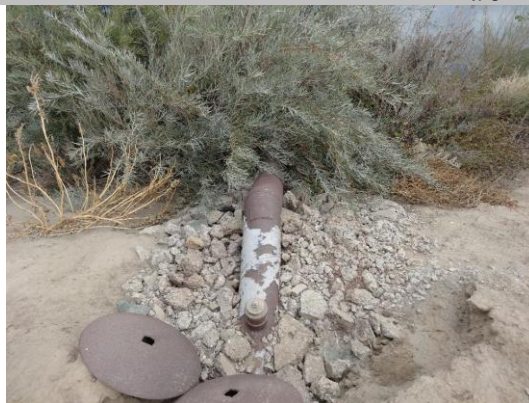
Photo 1 of 3 : UCIP_SP_2017_46671_44836.jpg

LM Start	2.43	Rating **	M	Issue No.	133 (cont)
LM End	2.43	Issue Type +	En	Location *	LS

WS view: exposed steel pipe and siphon breaker on levee slope.

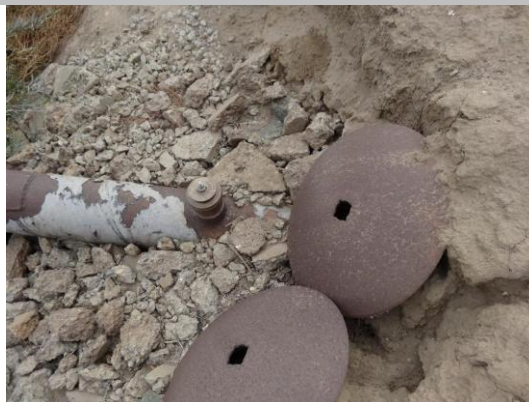
Photo 2 of 3 : UCIP_SP_2017_46671_44835.jpg

WS view: exposed steel pipe and soil erosion around siphon breaker on levee slope.

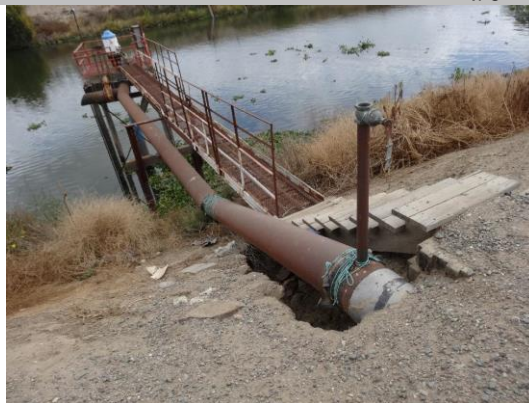
Photo 1 of 3 : UCIP_SP_2017_51361_44839.jpg

Comment Code					
Inspector Comment					
FS_ID:51361 DS_ID:22655 EP_NO: N/A Repair Type: Non-Urgent Crossing Status: Found UCIP Comments: 12/22/2016: Erosion has been backfilled. Slope has been repaired but unclear if the source of the erosion (a possible leak in pipe) was addressed. Crossing has been downgraded from Urgent to Non-Urgent. (K. Fazel - UCIP)10/29/2013:Siphon breaker on the landward shoulder not found.Service pole on landside.Huge erosion on landside and waterside of the levee due to the pipe leakage. (P. Amatya - DWR) FIELD_STRUCT_DESC: 12-inch steel irrigation pipe through the levee, 2 feet below the crown. Pump mounted on pile structure in the stream. Steel walkway to the pump. Air relief valve on the waterside (WS) shoulder. Concrete distribution box at the landside (LS) toe. [Additional Reference(s): DWR Levee Log, 2005. USACE San Joaquin O&M Manual 007, April 1964 (HLM 2.58)]. Note: O&M Manual cites a 16-inch at this location, 12 feet below the crown. FS Date: 12/22/2016

WS view: exposed pipe, walkway to pump, and pump on pile structure in the stream.

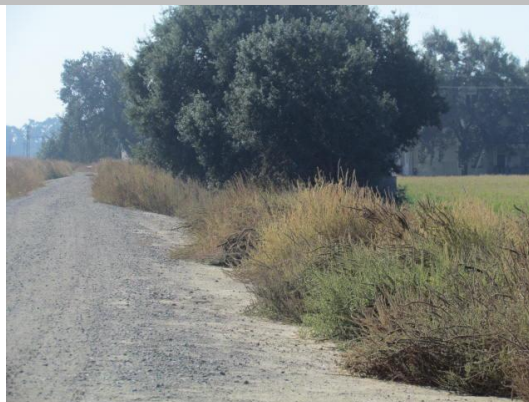
Photo 1 of 1 : SP_2017_RD0544_108_47_20170316_00037.jpg

LM Start	2.95	Rating **	U	Issue No.	47
LM End	3.19	Issue Type +	Ma	Location *	LS
Category	Earthen Levee			GPS Latitude/Longitude	
				Start	End
Item	Vegetation			37.840485 °	37.837225 °
				-121.318390 °	-121.317408 °
DWR ID	DWR_RD0544_01_s_2012_47				
Comment Code					
V2 : Remove the wild growth other than native grasses from the levee slopes.					
Inspector Comment

Looking south at dense veg on landward slope fall 2015.

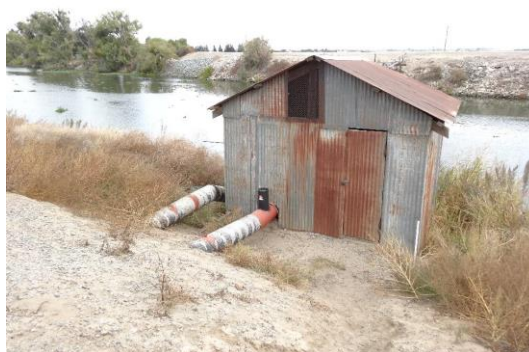
Photo 1 of 3 : UCIP_SP_2017_51365_42207.jpg

Comment Code					
Inspector Comment					
FS_ID:51365 DS_ID:22656 EP_NO: N/A Repair Type: Non-Urgent Crossing Status: Found UCIP Comments: 12/22/2016: Giant pit in LS slope has been backfilled, though no permit uncovered for this work. Unclear whether original source of damage (likely a leak in pipe) was addressed. Crossing has been downgraded from Urgent to Non-Urgent. (K. Fazel - UCIP)10/29/2013:- huge levee slope erosion on landside. Walkway to distro box on LS toe in poor structural condition.- 1-inch electric conduit, power pole on landside.- not clear whether this is a irrigation or drainage pipe. (P. Amatya - DWR) FIELD_STRUCT_DESC: 1 of 2: 14-inch steel irrigation pipe through the levee, 8 feet below the crown. Slide gates in 6-foot by 6-foot concrete distribution box at the landside (LS) toe. 1-inch electrical conduit through the levee at this location. Power pole on the LS toe. Pumphouse on waterside (WS) slope but no pump attached as per 2013 inspection. [Additional Reference(s): DWR Levee Log, 2005. USACE San Joaquin O&M Manual 007, April 1964 (HLM 3.19)]. FS Date: 12/22/2016

WS view: exposed steel pipes, levee slope, and pumphouse for 2nd pipe.

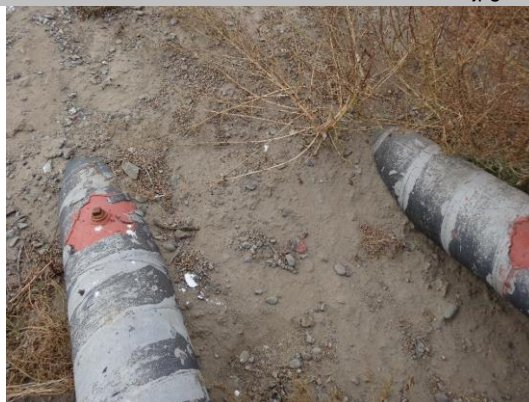
Photo 2 of 3 : UCIP_SP_2017_51365_42206.jpg

WS view: exposed steel pipes on levee slope.

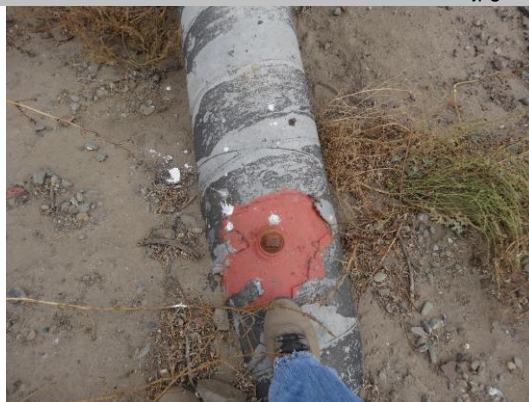
Photo 2 of 3 : UCIP_SP_2017_51366_44844.jpg

FS_ID:51366
DS_ID:22681
EP_NO: N/A
Repair Type: Non-Urgent
Crossing Status: Found
UCIP Comments: 12/22/2016: Giant pit in LS slope has been backfilled, though no permit uncovered for this work. Unclear whether original source of damage (likely a leak in pipe) was addressed. Crossing has been downgraded from Urgent to Non-Urgent. (K. Fazel - UCIP)10/29/2013:Huge erosion and levee damage on landside slope due to the leaky pipe. Walkway to distro box on LS toe in poor structural condition. (P. Amatya - DWR)
FIELD_STRUCT_DESC: 2 of 2: 14-inch steel irrigation pipe through the levee, 8 feet below the crown. Slide gates in 6-foot by 6-foot concrete distribution box at the landside (LS) toe. 1-inch electrical conduit through the levee at this location. Power pole on the LS toe. Pump house on waterside (WS) slope but no pump attached as per 2013 inspection. Flow meter on WS. [Additional Reference(s): DWR Levee Log, 2005. USACE San Joaquin O&M Manual 007, April 1964 (HLM 3.19)].

WS view: pipe daylights on levee slope. Siphon breaker removed and plugged.

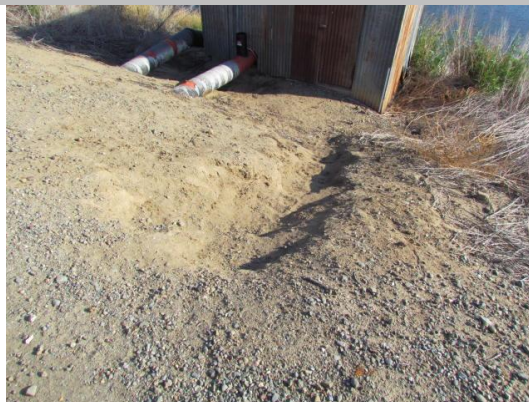
Photo 1 of 1 : SP_2017_RD0544_108_62_20170316_00045.jpg

LM Start	3.17	Rating **	M	Issue No.	62
LM End	3.17	Issue Type +	Ma	Location *	WS
Category	Earthen Levee			GPS Latitude/Longitude	
				Start	End
Item	Slope Stability			37.837530 °	37.837530 °
				-121.317510 °	-121.317510 °
DWR ID	DWR_RD0544_01_s_2012_62				
Comment Code					
S2 : Repair the levee slope damaged by foot traffic and prevent access where possible.					
Inspector Comment					
Slope damage due to foot traffic.

Looking east at slope damaged by foot traffic near pump house on waterside of levee.

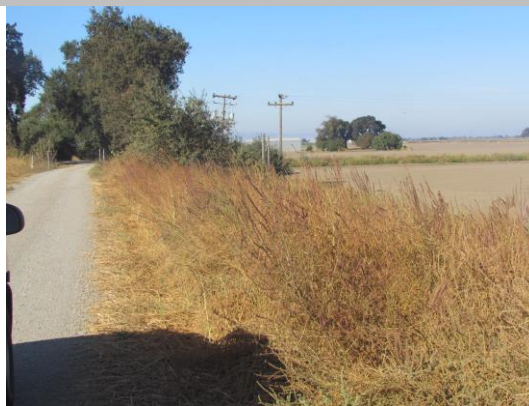
Photo 1 of 1 : SP_2017_RD0544_108_48_20170316_00038.jpg

LM Start	3.23	Rating **	U	Issue No.	48
LM End	3.26	Issue Type +	Ma	Location *	LS
Category	Earthen Levee			GPS Latitude/Longitude	
				Start	End
Item	Vegetation			37.836615 °	37.836133 °
				-121.317285 °	-121.317153 °
DWR ID	DWR_RD0544_01_s_2012_48				
Comment Code					
V2 : Remove the wild growth other than native grasses from the levee slopes.					
Inspector Comment

Looking south at typical view of dense veg on landward slope.

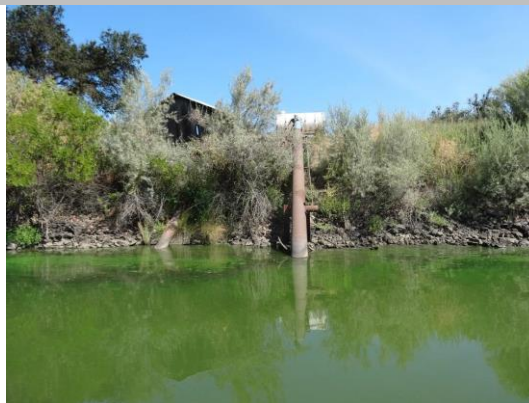
Photo 2 of 2 : SP_2017_RD0544_108_84_20170316_00053.jpg

LM Start	4.23	Rating **	M	Issue No.	84 (cont)
LM End	4.24	Issue Type +	Ma	Location *	WS
Category	Supplemental			GPS Latitude/Longitude	
				Start	End
Item	DWR Erosion Survey			37.825248 °	37.825248 °
				-121.313856 °	-121.313856 °
DWR ID	DWR_RD0544_01_s_2017_84				
Comment Code					
Inspector Comment					
07/25/2016: No significant change observed.					
06/24/2015: No significant change observed.					
06/19/2014: No significant change observed.					
08/13/2013: The erosion has been caused by irrigation pipe. [2016 Site ID:RD0544U01RM51.04]

Close view of the site.

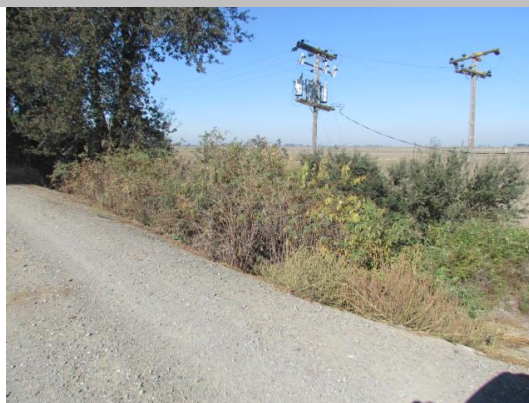
Photo 1 of 1 : SP_2017_RD0544_108_57_20170316_00042.jpg

LM Start	4.24	Rating **	U	Issue No.	57
LM End	4.49	Issue Type +	Ma	Location *	LS
Category	Earthen Levee			GPS Latitude/Longitude	
				Start	End
Item	Vegetation			37.825517 °	37.822955 °
				-121.314160 °	-121.316835 °
DWR ID	DWR_RD0544_01_s_2012_57				
Comment Code					
V4 : Elderberries are blocking visibility and flood fight capability.					
Inspector Comment					
Dense elderberry on landward slope and toe.

Looking southwest at dense elderberries on landward slope fall 2015.

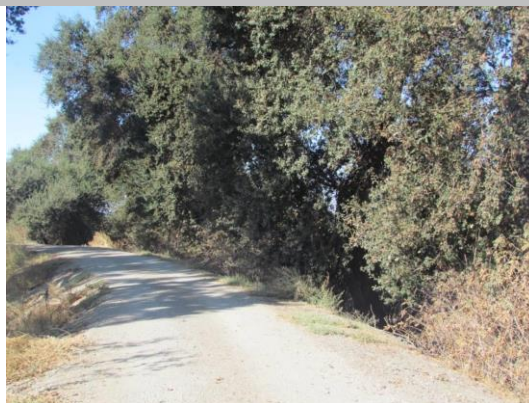
Photo 1 of 1 : SP_2017_RD0544_108_120_20170316_00079.jpg

LM Start	4.25	Rating **	U	Issue No.	120
LM End	4.28	Issue Type +	Ma	Location *	LS
Category	Earthen Levee			GPS Latitude/Longitude	
				Start	End
Item	Trim / Thin Trees			37.825482 °	37.825229 °
				-121.314298 °	-121.314771 °
DWR ID	DWR_RD0544_01_f_2015_120				
Comment Code					
T1 : Trim trees to at least five feet above ground level.					
Inspector Comment					
Several untrimmed trees on landward slope.

Looking southwest at untrimmed trees on landward slope.

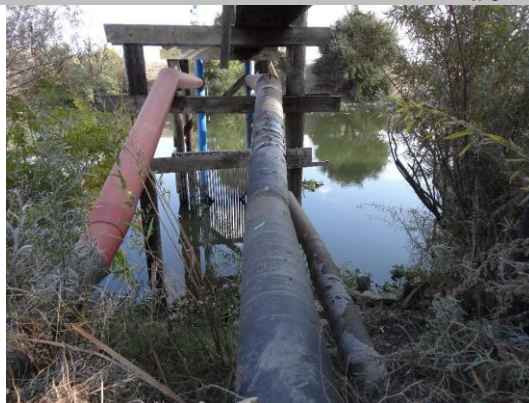
Photo 1 of 3 : UCIP_SP_2017_24893_44858.jpg

Comment Code					
Inspector Comment					
FS_ID:24893 DS_ID:22660 EP_NO: 11536 Repair Type: Non-Urgent Crossing Status: Found UCIP Comments: - siphon breaker was removed from CMP riser on landside shoulder. Needs replacement.- some details about existing pipes available in new Application no. 18903.- electric control box on landside and conduit on waterside. FIELD_STRUCT_DESC: 1 of 3: 12-inch diameter steel irrigation pipe, 16-inch diameter steel irrigation pipe and an 8-inch diameter steel discharge pipe through the levee, 3.0 feet below the crown. Pump on pump platform in channel with a walkway to the waterward slope. Siphon breaker in CMP riser and concrete standpipe on landside. (App. No. 11536-Phelps) O&M Manual SJR 007, April 1964. FS Date: 10/29/2013

WS view: pipes, pumps, walkway to pump, and pile structure in the stream.

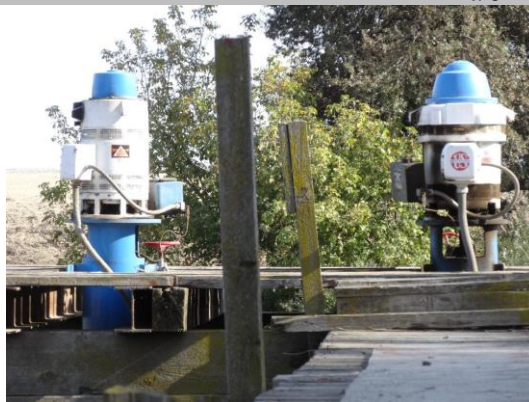
Photo 2 of 3 : UCIP_SP_2017_24893_44857.jpg

WS view: pumps, walkway to pump, and pile structure in the stream.

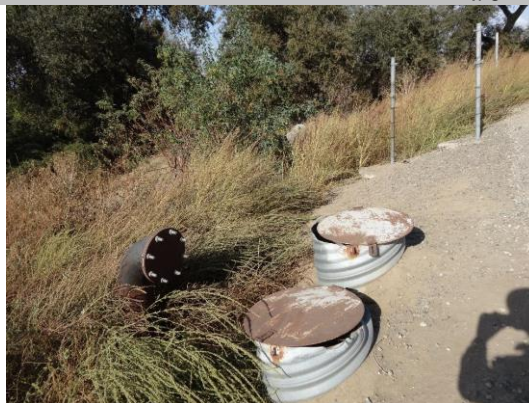
Photo 3 of 3 : UCIP_SP_2017_24893_44856.jpg

LS view: CMP riser (top- for 12" pipe), CMP riser (bottom- for 16" pipe), and capped steel pipe (left)

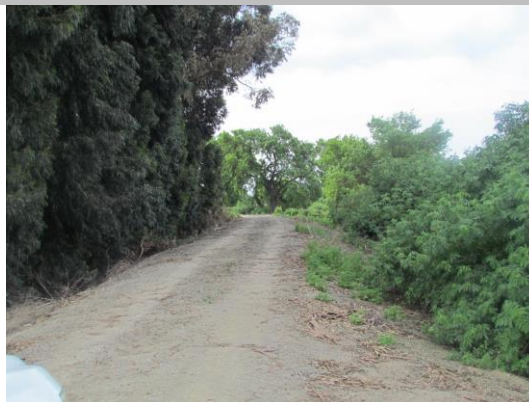
Photo 1 of 1 : SP_2017_RD0544_108_59_20170410_00136.jpg

LM Start	4.30	Rating **	M	Issue No.	59
LM End	4.30	Issue Type +	Ma	Location *	LS
Category	Earthen Levee			GPS Latitude/Longitude	
				Start	End
Item	Vegetation			37.824943 °	37.824943 °
				-121.315008 °	-121.315008 °
DWR ID	DWR_RD0544_01_s_2012_59				
Comment Code					
V4 : Elderberries are blocking visibility and flood fight capability.					
Inspector Comment

Looking south at dense veg on landward and waterward slopes.

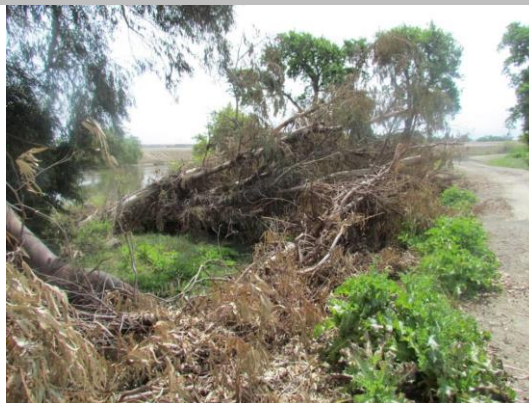
Photo 1 of 1 : SP_2017_RD0544_108_100_20170410_00137.jpg

LM Start	4.34	Rating **	U	Issue No.	100
LM End	4.34	Issue Type +	Ma	Location *	WS
Category	Earthen Levee			GPS Latitude/Longitude	
				Start	End
Item	Encroachments			37.824373 °	37.824373 °
				-121.315207 °	-121.315207 °
DWR ID	DWR_RD0544_01_s_2017_100				
Comment Code					
TR : Tree or limb					
Inspector Comment					
Broken tree limbs and branches on waterward slope.

Looking south at broken tree limb and branches on waterward slope.

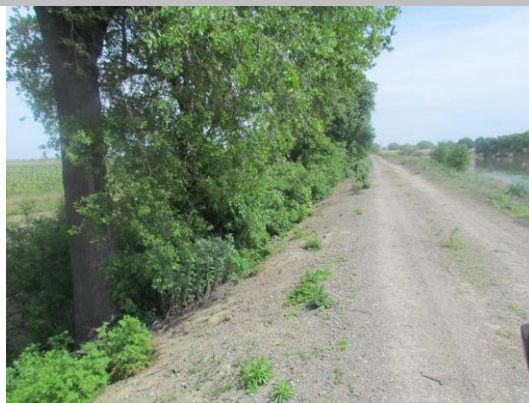
Photo 1 of 1 : SP_2017_RD0544_108_54_20170410_00138.jpg

LM Start	4.37	Rating **	U	Issue No.	54
LM End	6.05	Issue Type +	Ma	Location *	LS
Category	Earthen Levee			GPS Latitude/Longitude	
				Start	End
Item	Vegetation			37.824018 °	37.808766 °
				-121.315247 °	-121.328198 °
DWR ID	DWR_RD0544_01_s_2012_54				
Comment Code					
V2 : Remove the wild growth other than native grasses from the levee slopes.					
Inspector Comment

Looking northwest at dense veg. on landward slope.

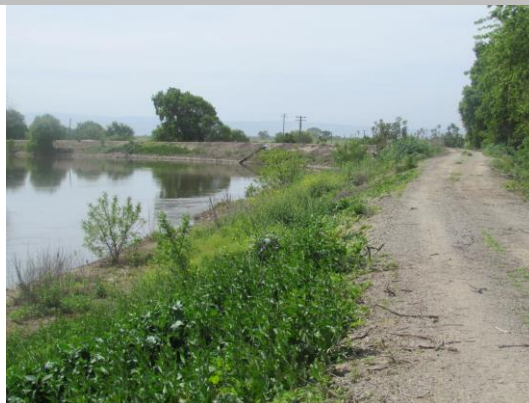
Photo 1 of 1 : SP_2017_RD0544_108_117_20170410_00139.jpg

LM Start	4.41	Rating **	M	Issue No.	117
LM End	4.79	Issue Type +	Ma	Location *	WS
Category	Earthen Levee			GPS Latitude/Longitude	
				Start	End
Item	Vegetation			37.823522 °	37.820557 °
				-121.315735 °	-121.321217 °
DWR ID	DWR_RD0544_01_s_2017_117				
Comment Code					
V2 : Remove the wild growth other than native grasses from the levee slopes.					
Inspector Comment

Looking south at dense veg on waterward slope.

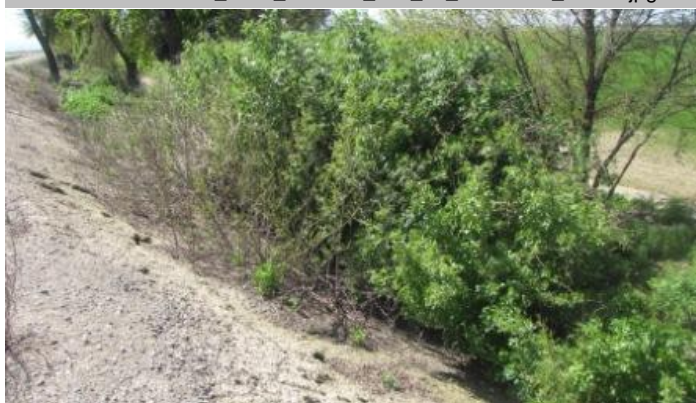
Photo 1 of 1 : SP_2017_RD0544_108_41_20170316_00031.jpg

LM Start	4.49	Rating **	U	Issue No.	41
LM End	4.49	Issue Type +	Ma	Location *	LS
Category	Earthen Levee			GPS Latitude/Longitude	
				Start	End
Item	Vegetation			37.822934 °	37.822934 °
				-121.316870 °	-121.316870 °
DWR ID	DWR_RD0544_01_s_2012_41				
Comment Code					
V4 : Elderberries are blocking visibility and flood fight capability.					
Inspector Comment

Looking south at elderberries on landside slope and toe.

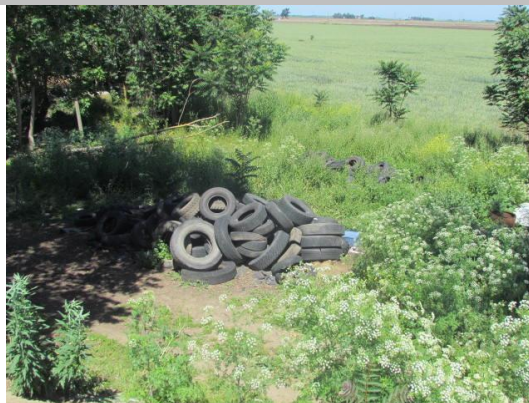
Photo 1 of 1 : SP_2017_RD0544_108_27_20170316_00021.jpg

LM Start	4.68	Rating **	U	Issue No.	27
LM End	4.69	Issue Type +	En	Location *	LS
Category	Earthen Levee			GPS Latitude/Longitude	
				Start	End
Item	Encroachments			37.821847 °	37.821793 °
				-121.320027 °	-121.320188 °
DWR ID	DWR_RD0544_01_s_2012_27				
Comment Code					
GA : Garbage					
Inspector Comment					
Tires stock pile on landward toe.

Looking west at tires stock pile on landward berm.

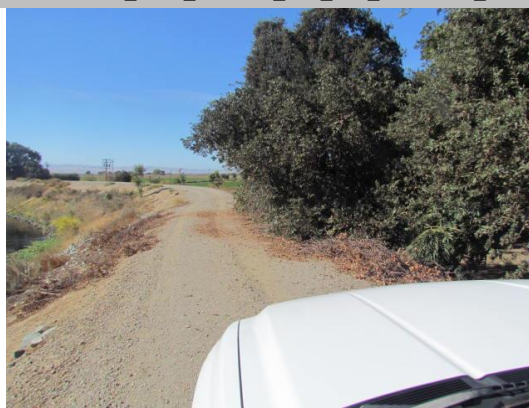
Photo 1 of 1 : SP_2017_RD0544_108_105_20170316_00066.jpg

LM Start	4.69	Rating **	U	Issue No.	105
LM End	4.69	Issue Type +	Ma	Location *	LS
Category	Earthen Levee			GPS Latitude/Longitude	
				Start	End
Item	Trim / Thin Trees			37.821775 °	37.821775 °
				-121.320203 °	-121.320203 °
DWR ID	DWR_RD0544_01_f_2014_105				
Comment Code					
T2 : Thin trees to allow visibility of the ground and room to flood fight.					
Inspector Comment					
Tree has overgrown onto levee crown.

Looking south at overgrown tree on landward shoulder.

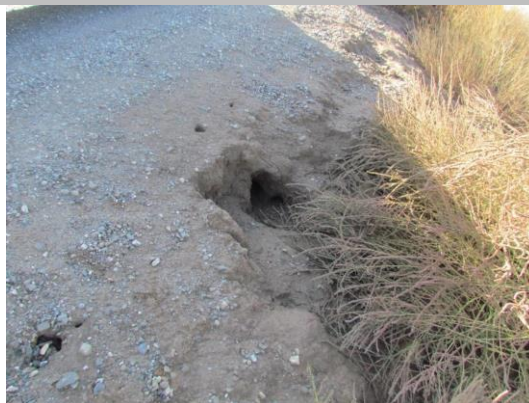
Photo 1 of 1 : SP_2017_RD0544_108_83_20170316_00051.jpg

LM Start	4.74	Rating **	U	Issue No.	83
LM End	4.74	Issue Type +	Ma	Location *	LS
Category	Earthen Levee			GPS Latitude/Longitude	
				Start	End
Item	Animal Control			37.821287 °	37.821287 °
				-121.320897 °	-121.320897 °
DWR ID	DWR_RD0544_01_f_2016_83				
Comment Code					
A3 : No rodents visible, but rodent burrows visible; need to backfill and compact or grout burrows.					
Inspector Comment					
Large rodent hole on waterward shoulder.

Looking at large rodent hole on landward slope.

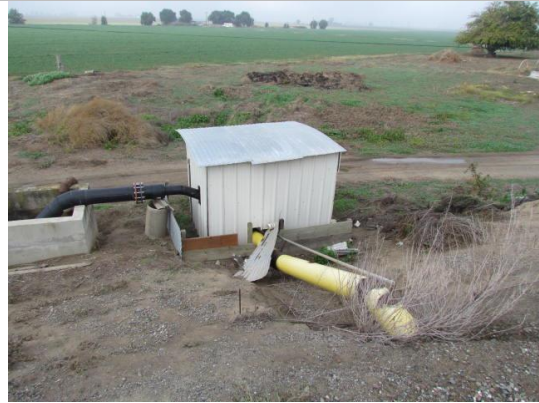
Photo 1 of 1 : SP_2017_RD0544_108_45_20170316_00034.jpg

LM Start	4.75	Rating **	M	Issue No.	45
LM End	4.75	Issue Type +	En	Location *	LS
Category	Earthen Levee			GPS Latitude/Longitude	
				Start	End
Item	Encroachments			37.821177 °	37.821177 °
				-121.321013 °	-121.321013 °
DWR ID	DWR_RD0544_01_s_2012_45				
Comment Code					
BU : Building					
Inspector Comment					
New unauthorized pump shed on landside toe.

Looking west at a unauthorized pump house on landside toe.

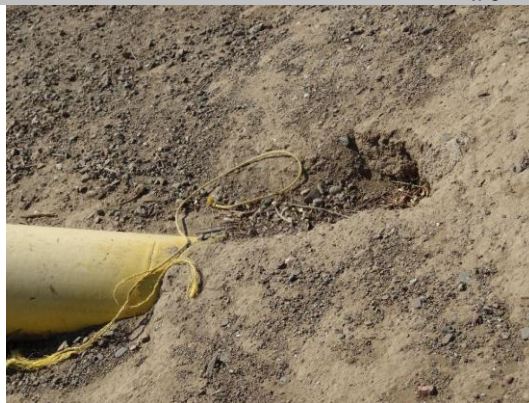
Photo 2 of 3 : UCIP_SP_2017_51379_44863.jpg

FS_ID:51379
DS_ID:22661
EP_NO: N/A
Repair Type: Urgent
Crossing Status: Found
UCIP Comments: 12/22/2016: LS slope still eroded and in need of repair. WS slope shows no signs of problems. (K. Fazel - UCIP)10/31/2013:- huge erosion on landside slope due to leaky pipe.- small depression on waterside slope. (P. Amatya - DWR)
FIELD_STRUCT_DESC: 12-inch steel irrigation pipe through the levee, 4.4 feet below the crown. Pump house on the landside (LS) slope. Newly installed pump with shut-off valve on waterside (WS) slope. Pressure relief valve on the LS slope. Concrete distribution box with shut-off valve on pipe at the LS toe. [Additional Reference(s): DWR Levee Log, 2005. USACE San Joaquin O&M Manual 007, April 1964 (HLM 4.79)]. Note: O&M Manual cites a depth below crown of 12 feet.
FS Date: 12/22/2016

WS view: exposed steel pipe and a small depression on levee slope. May be due to leaky pipe.

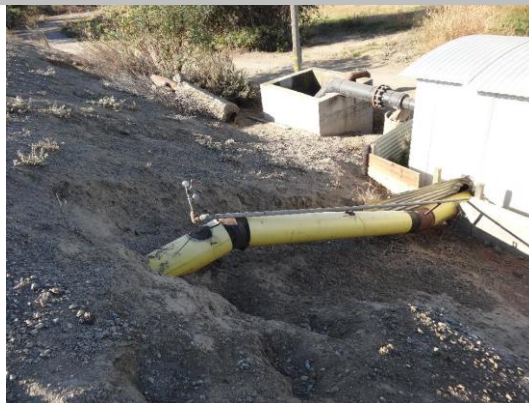
Photo 3 of 3 : UCIP_SP_2017_51379_44862.jpg

LS view: distribution box (top-left), pumphouse (right) and exposed leaky pipe on eroded levee slope.

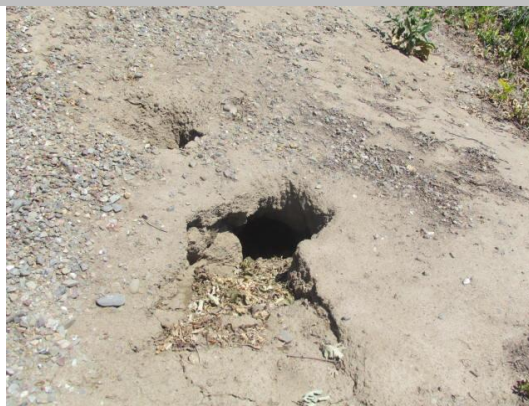
Photo 1 of 1 : SP_2017_RD0544_108_113_20170316_00071.jpg

LM Start	4.77	Rating **	U	Issue No.	113
LM End	4.77	Issue Type +	Ma	Location *	WS
Category	Earthen Levee			GPS Latitude/Longitude	
				Start	End
Item	Animal Control			37.820828 °	37.820828 °
				-121.321193 °	-121.321193 °
DWR ID	DWR_RD0544_01_s_2015_113				
Comment Code					
A3 : No rodents visible, but rodent burrows visible; need to backfill and compact or grout burrows.					
Inspector Comment					
Large hole, possibly a rodent hole, on waterward slope.

Looking north at large hole on waterward slope.

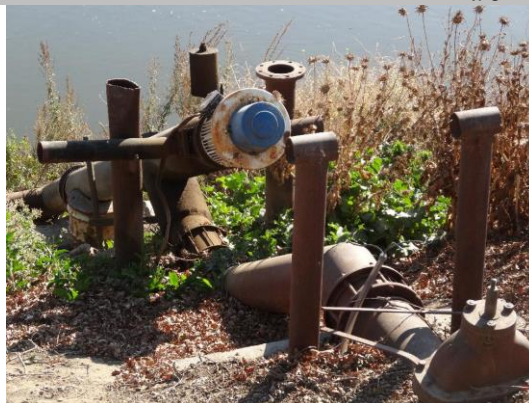
Photo 1 of 3 : UCIP_SP_2017_42962_42877.jpg

LM Start	4.78	Rating **	M	Issue No.	140
LM End	4.78	Issue Type +	En	Location *	WS
Category	Supplemental			GPS Latitude/Longitude	
				Start	End
Item	DWR UCIP Field Study			37.820691 °	37.820691 °
				-121.321159 °	-121.321159 °
DWR ID					
Comment Code					
Inspector Comment					
FS_ID:42962 DS_ID:22662 EP_NO: 1738 Repair Type: Non-Urgent Crossing Status: Found UCIP Comments: Appears abandoned and if so should be done so properly. No handle on gatevalve on WS slope. FIELD_STRUCT_DESC: 12-inch diameter steel pipe through the levee, 6.0 feet below the crown. Gate valve on the waterward slope. Slant pump on the waterward slope. An electric conduit on landside, service pole on landside and two concrete standpipes on landside. (Permit No. 1738 - Barker Corp.) O&M Manual SJR 007, April 1964. FS Date: 10/31/2013

WS view: slant pump on steel framed support, gate valve, and headwall on levee slope.

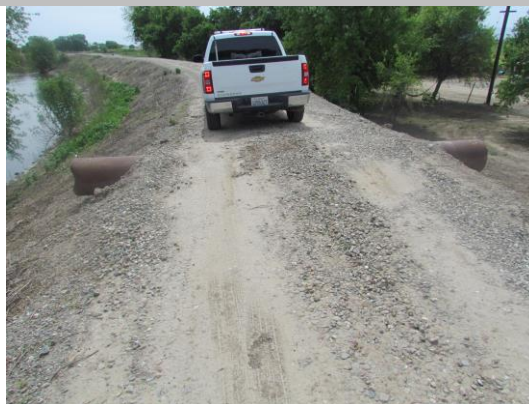
Photo 1 of 1 : SP_2017_RD0544_108_28_20170410_00140.jpg

LM Start	4.80	Rating **	U	Issue No.	28
LM End	4.80	Issue Type +	Ma	Location *	CR
Category	Earthen Levee			GPS Latitude/Longitude	
				Start	End
Item	Crown Surface / Depressions / Rutting			37.820412 °	37.820412 °
				-121.321193 °	-121.321193 °
DWR ID	DWR_RD0544_01_s_2017_28				
Comment Code					
Inspector Comment					
Pipe installed near surface of crown. Pipe is not connected on either side.

Looking south at pipe across levee crown.

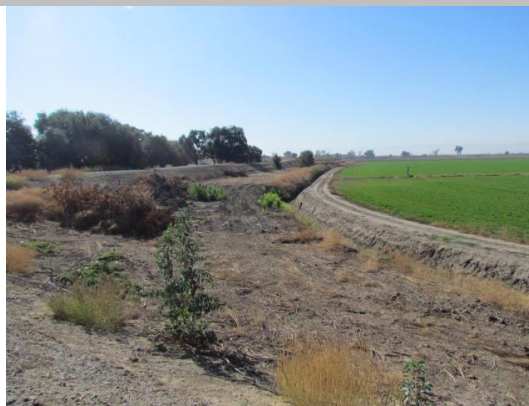
Photo 1 of 2 : SP_2017_RD0544_108_33_20170316_00024.jpg

LM Start	4.95	Rating **	M	Issue No.	33
LM End	5.26	Issue Type +	Ma	Location *	LS
Category	Earthen Levee			GPS Latitude/Longitude	
				Start	End
Item	Vegetation			37.818718 °	37.814662 °
				-121.319508 °	-121.320302 °
DWR ID	DWR_RD0544_01_s_2012_33				
Comment Code					
V2 : Remove the wild growth other than native grasses from the levee slopes.					
Inspector Comment					
Vegetation has been sprayed, and it should be monitored.

Looking southwest at cleared landward slope and berm fall 2015.

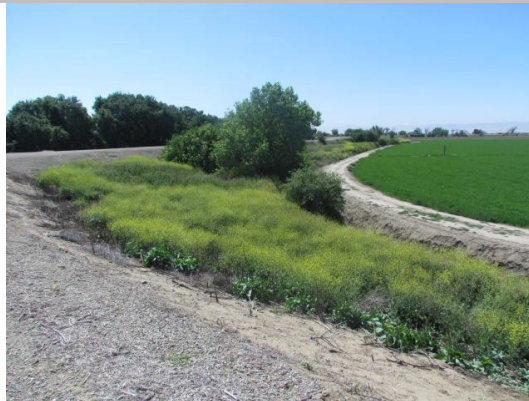
Photo 2 of 2 : SP_2017_RD0544_108_33_20170316_00025.jpg

Looking southwest at dense vegetation at landward slope and toe.(Spring 2015)

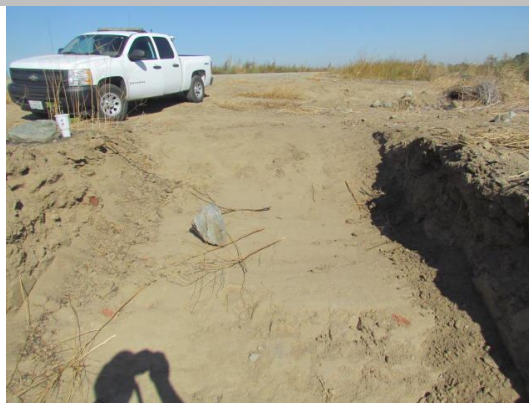
Photo 1 of 4 : SP_2017_RD0544_108_121_20170316_00080.jpg

LM Start	5.60	Rating **	U	Issue No.	121
LM End	5.60	Issue Type +	Ma	Location *	WS
Category	Earthen Levee			GPS Latitude/Longitude	
				Start	End
Item	Erosion / Bank Caving			37.811234 °	37.811234 °
				-121.321412 °	-121.321412 °
DWR ID	DWR_RD0544_01_f_2015_121				
Comment Code					
E2 : Schedule repair of erosion site prior to the next inspection.					
Inspector Comment					
Someone digging/excavating on waterward berm. Excavation in 3ft wide and eighteen inches deep and ten feet long.

Looking west at excavation on waterward berm.

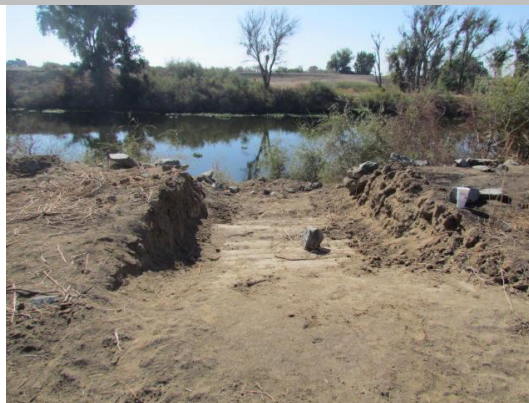
Photo 2 of 4 : SP_2017_RD0544_108_121_20170316_00081.jpg

Looking east at excavation on waterward berm.

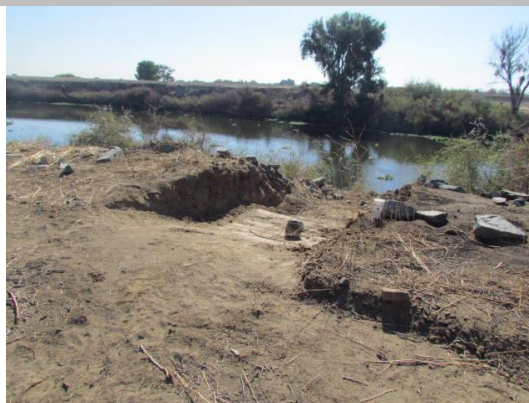
Photo 3 of 4 : SP_2017_RD0544_108_121_20170316_00082.jpg

Looking northeast at excavation on waterward berm

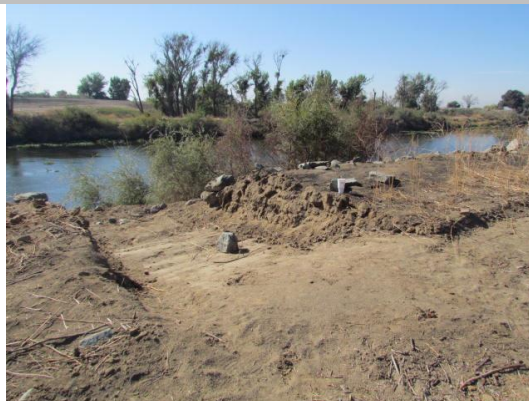
Photo 4 of 4 : SP_2017_RD0544_108_121_20170316_00083.jpg

Looking southeast at excavation on waterward berm.

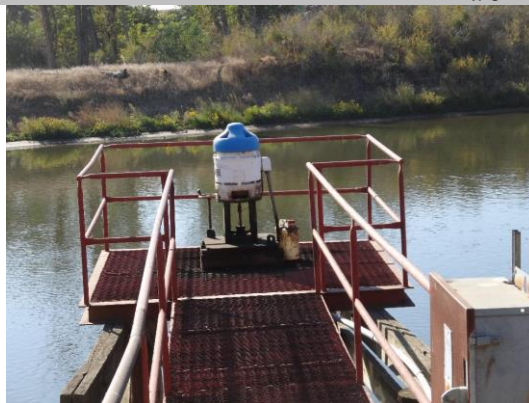
Photo 2 of 3 : UCIP_SP_2017_51384_42871.jpg

FS_ID:51384
DS_ID:22664
EP_NO: N/A
Repair Type: Urgent
Crossing Status: Found
UCIP Comments: 12/22/2016: LS slope just above pipe is eroded with a giant pit exposing the electrical conduit. Crossing has been upgraded from Non-Urgent to Urgent. (K. Fazel - UCIP)10/31/2013:- 2-inch electric conduit on waterside- service pole on landside.- needs a cover on pressure relief valve. (P. Amatya - DWR)
FIELD_STRUCT_DESC: 16-inch steel irrigation pipe through the levee, 5.3 feet below the crown. Pump mounted on a pile structure in the stream. Steel walkway to the pump. Pressure relief valve in butterfly configuration at apex of the pipe on the landside (LS). Two 36-inch concrete standpipes on the LS toe. Electrical conduit through the levee and power pole at the LS toe. [Additional Reference(s): DWR Levee Log, 2005. USACE San Joaquin O&M Manual 007, April 1964 (HLM 5.77)].
FS Date: 12/22/2016

WS view: pump on pile structure in the stream. Oil leaking pump.

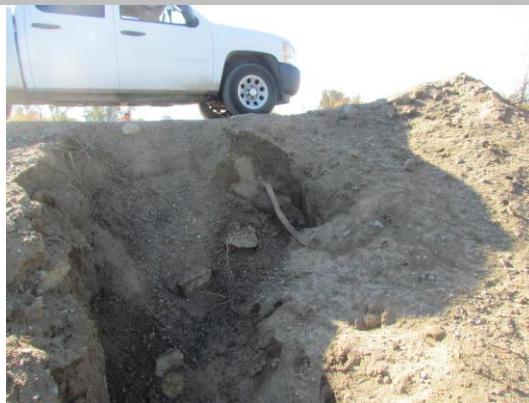
Photo 1 of 3 : SP_2017_RD0544_108_115_20170316_00072.jpg

LM Start	5.72	Rating **	U	Issue No.	115
LM End	5.72	Issue Type +	Ma	Location *	LS
Category	Earthen Levee			GPS Latitude/Longitude	
				Start	End
Item	Slope Stability			37.811225 °	37.811225 °
				-121.323575 °	-121.323575 °
DWR ID	DWR_RD0544_01_s_2015_115				
Comment Code					
S2 : Repair the levee slope damaged by foot traffic and prevent access where possible.					
Inspector Comment					
Landowner excavated hole above pipe.Large hole left on landward shoulder and slope. Call LMA about repair.

Looking west at large excavation on landward slope.

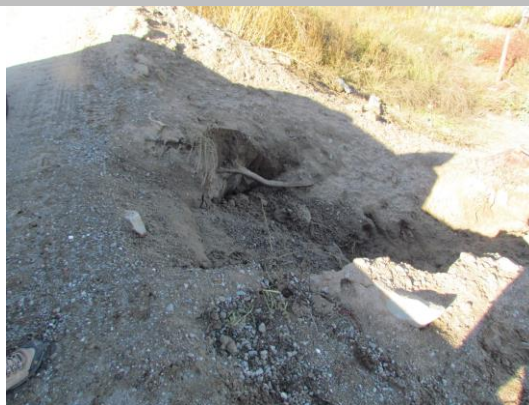
Photo 2 of 3 : SP_2017_RD0544_108_115_20170316_00073.jpg

Looking south at large excavation on landward slope.

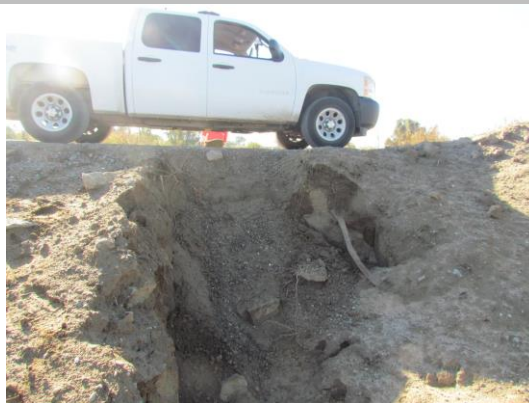
Photo 3 of 3 : SP_2017_RD0544_108_115_20170316_00074.jpg

Looking westly at large excavation on landward slope.

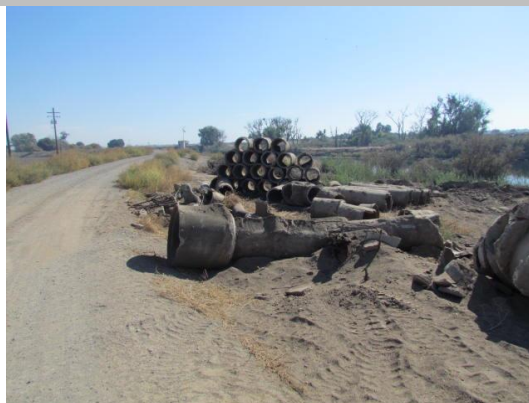
Photo 1 of 1 : SP_2017_RD0544_108_122_20170316_00084.jpg

LM Start	5.79	Rating **	U	Issue No.	122
LM End	5.79	Issue Type +	En	Location *	WS
Category	Earthen Levee			GPS Latitude/Longitude	
				Start	End
Item	Encroachments			37.811271 °	37.811271 °
				-121.324903 °	-121.324903 °
DWR ID	DWR_RD0544_01_f_2015_122				
Comment Code					
GA : Garbage					
Inspector Comment					
Stockpile of concrete pipes on waterward slope and berm.

Looking northeast at concrete pipes stockpiled at waterward shoulder and slope.
